Windows 10 Hardware/Software Changes

What is it:

This is the next generation of kiosk PC hardware and it only supports Windows 10 and higher. This is a hardware limitation on all new PC motherboards (Premio Only) moving forward from manufacturers. Windows 10 sees a number of changes to both hardware and software. All changes are included on their relevant pages. i.e. differences in Arcus software from Windows 7 to Windows 10 are included on the Arcus Driver Reinstall page.

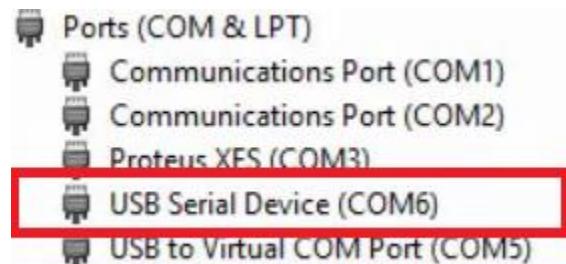
For Windows 10 the EMV will show as USB Serial Device under ports.
Add/Remove Programs will not contain the .net software or the Ingenico driver.

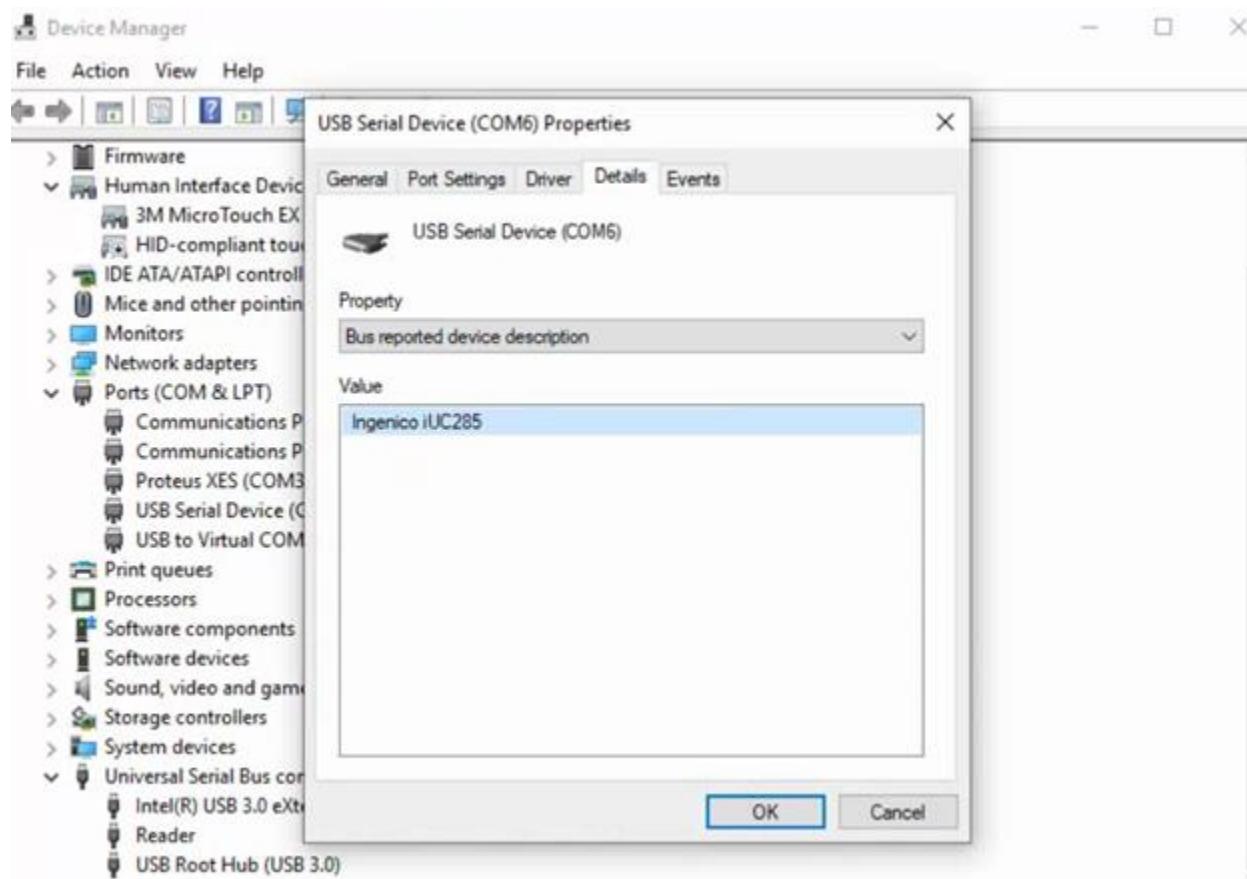
You can confirm this by right clicking -> properties -> Details -> bus reported device description

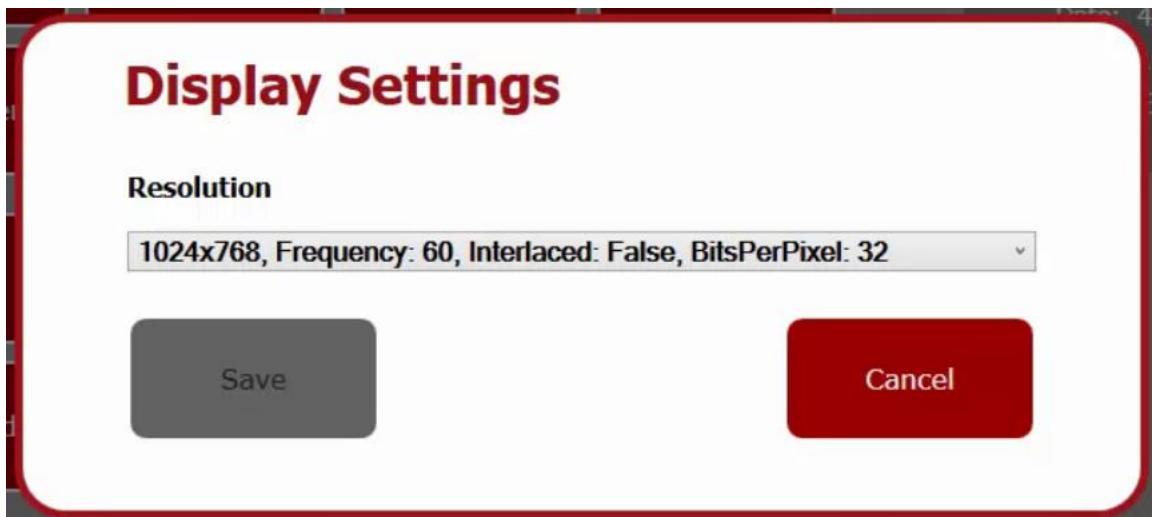
Windows 10 PCs will show a drop down option for resolution when clicking 'Display'

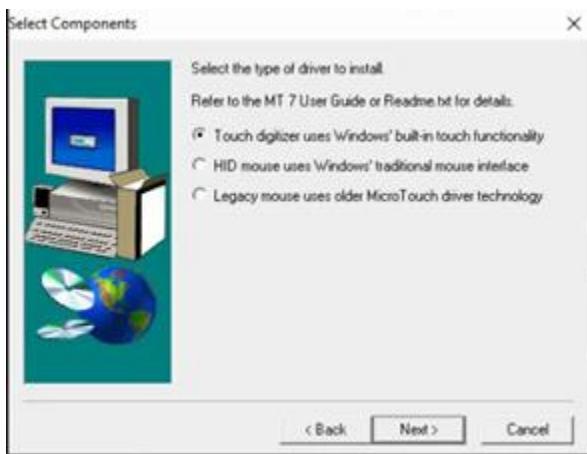
During driver installation on Win 10, select the 'digitizer' option.

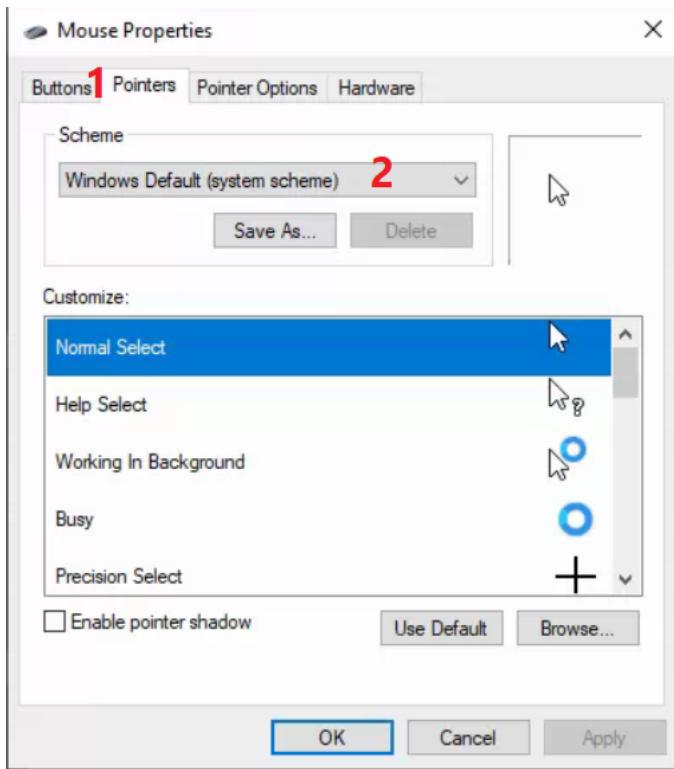
Click on 'Pointers' (1) then from the dropdown (2) select 'Windows Default' and Apply.

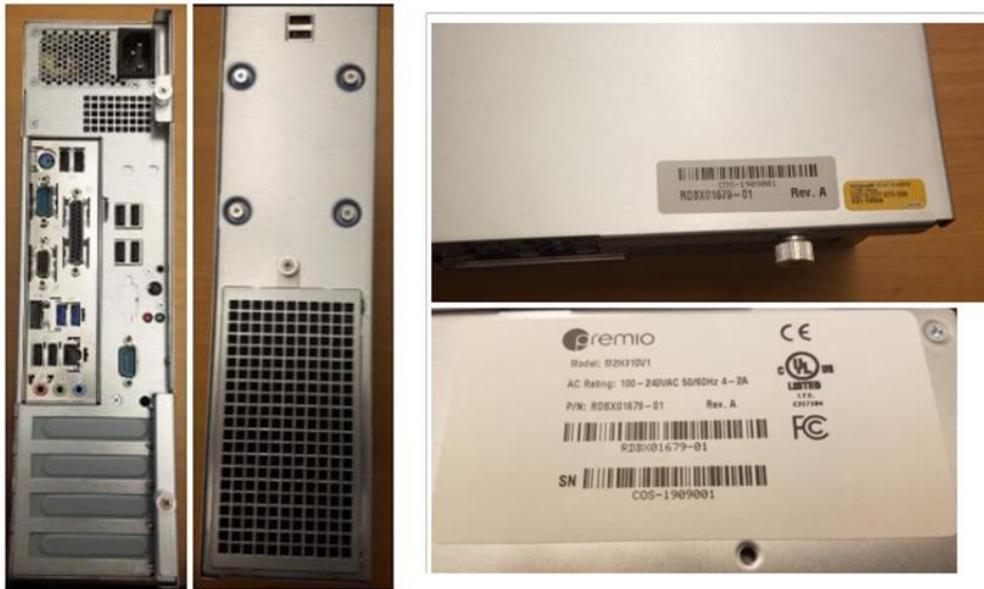
RDBX01679

New PC's will have the following part number and description with these typical labeling locations:

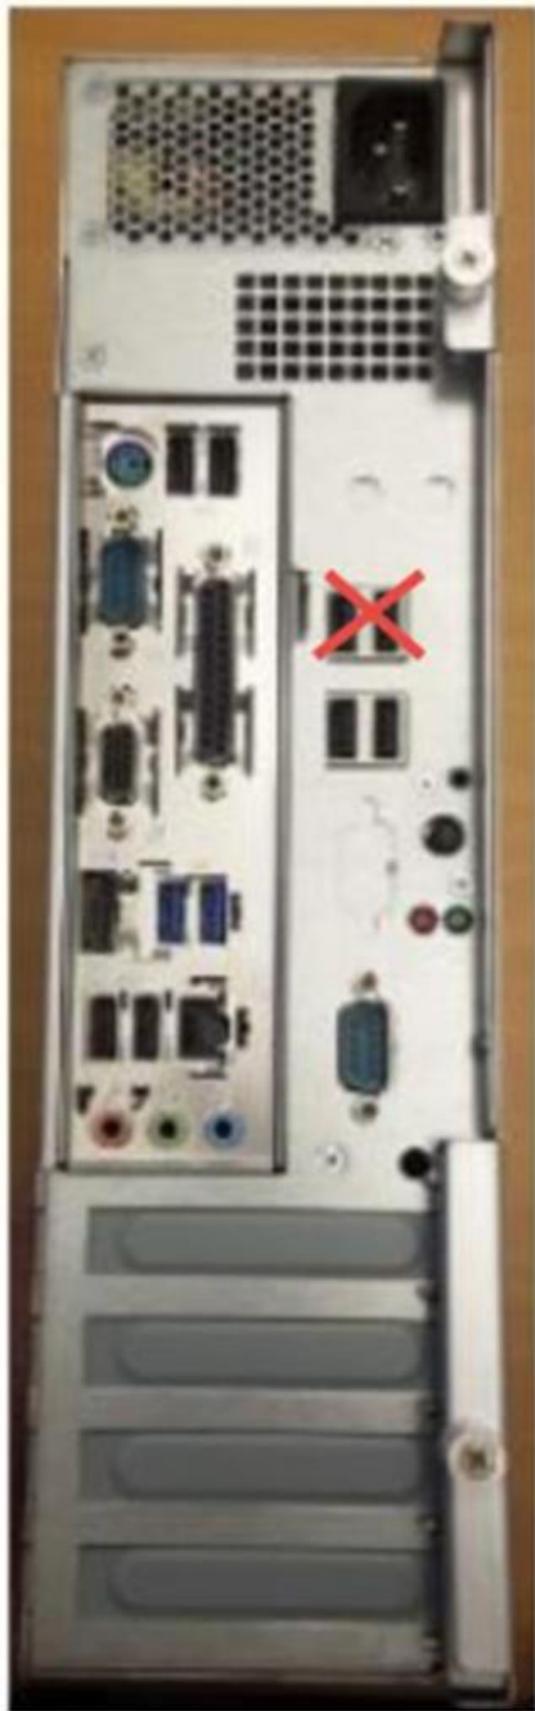
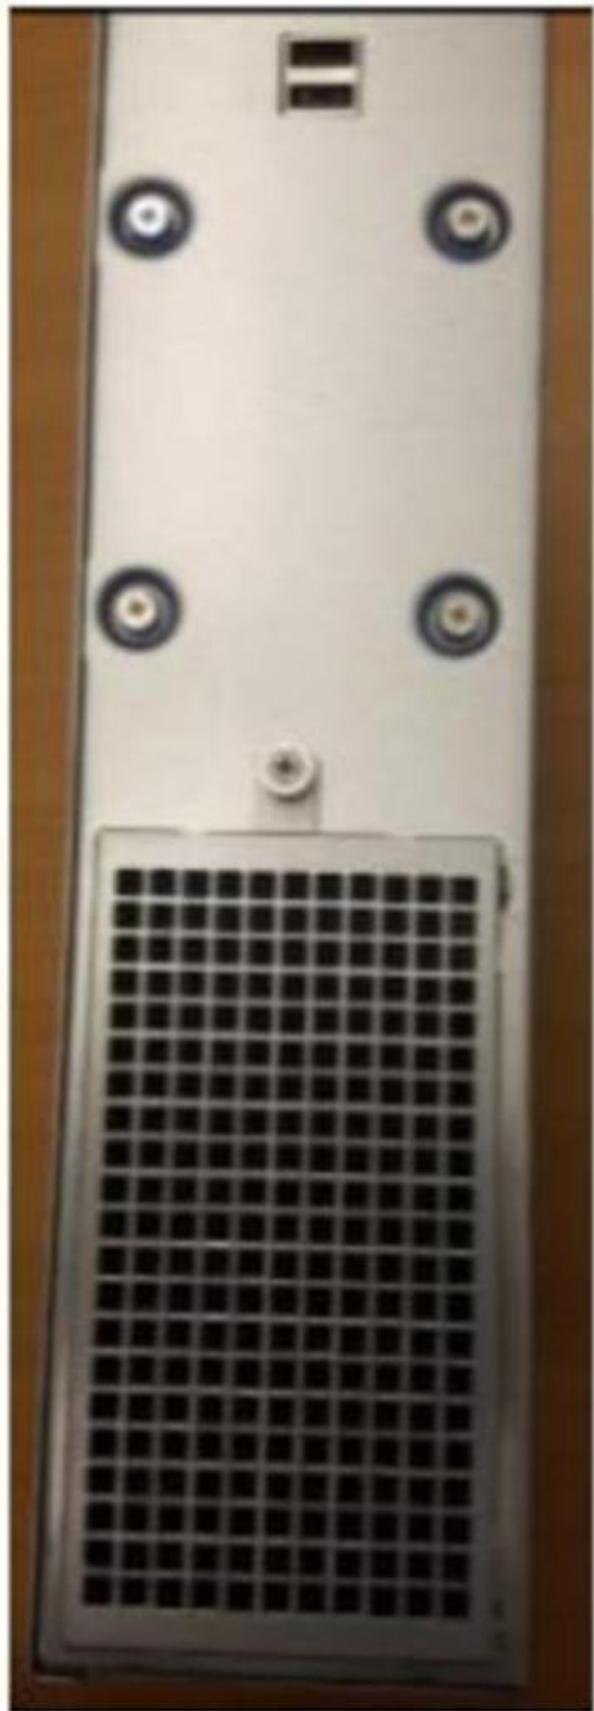
Important Note: The crossed off USB ports are inactive on Windows 10 models and will be covered with insert-able dust covers. Any device plugged into these ports **will not work**.

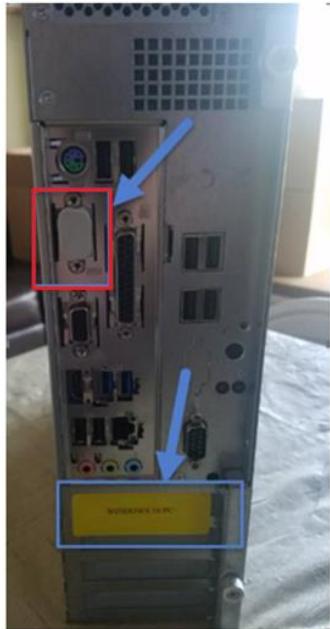
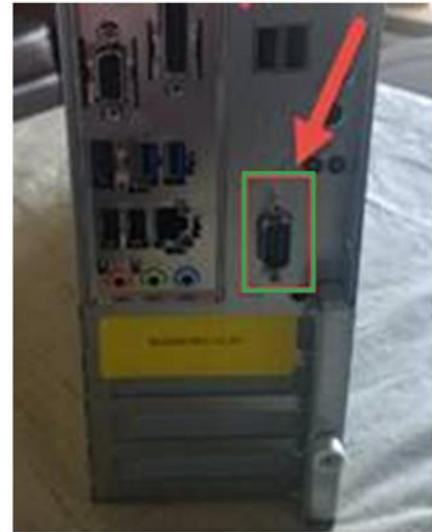
The unused serial port should be capped as shown below and labeled with a sticker indicating a Windows 10 PC.
